## Engineering Study

### Townhouse Road and New Bridge Road over Northeast Pond

Milton-Lebanon 40658

NHDOT Bridge No. 168/151

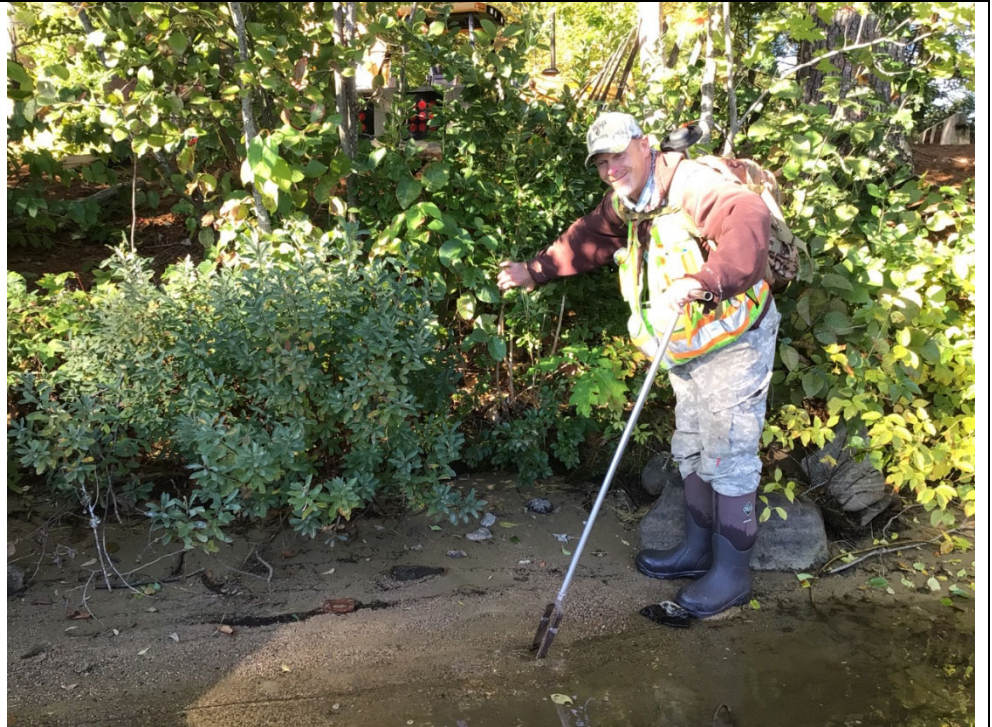
Representative view of Ordinary High Water Mark and Bank on eastern side of the New Bridge Road.

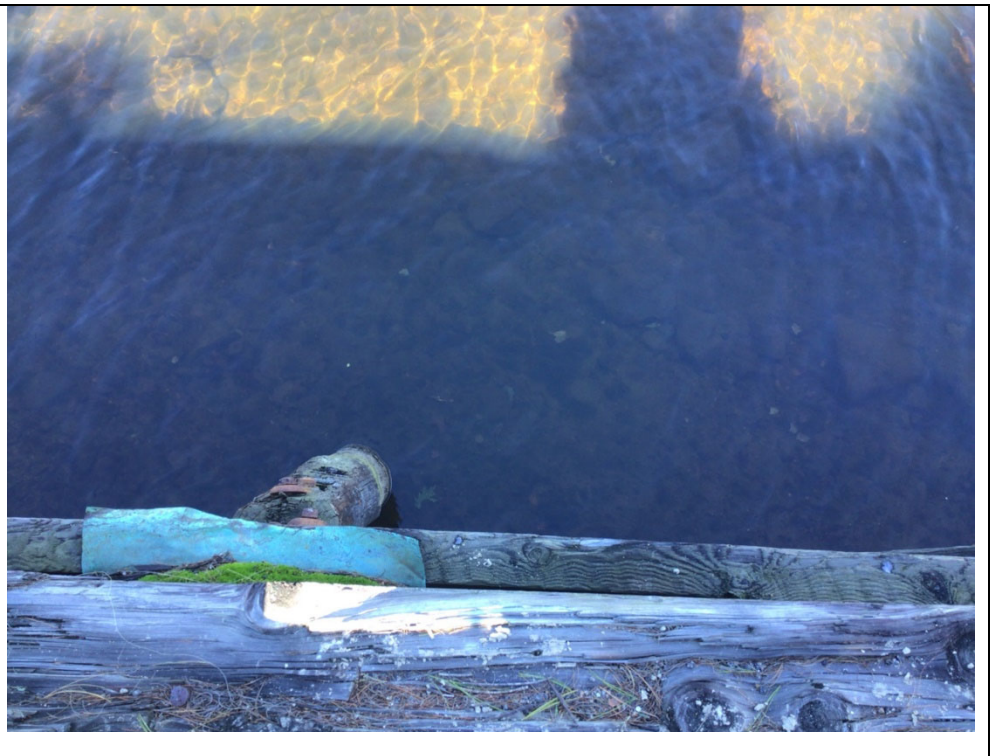
View of aquatic substrate adjacent to existing bridge abutment in Maine.

Maximum depths in the vicinity of the bridge crossing range from approximately two to seven feet. Average channel cross sections of Northeast Pond in the vicinity of the bridge are generally parabolic-shaped and water depths generally increase gradually from both shorelines. The majority of observed substrate in Northeast Pond in the vicinity of the bridge is dominated by coarse gravel, rubble, small to medium cobble, and scattered small boulders. Less coarse sandy substrates are located both to the west and east of the proposed bridge crossing along exposed beaches (see Appendix I). Sections of riprap exist along the edges of each existing bridge abutment.

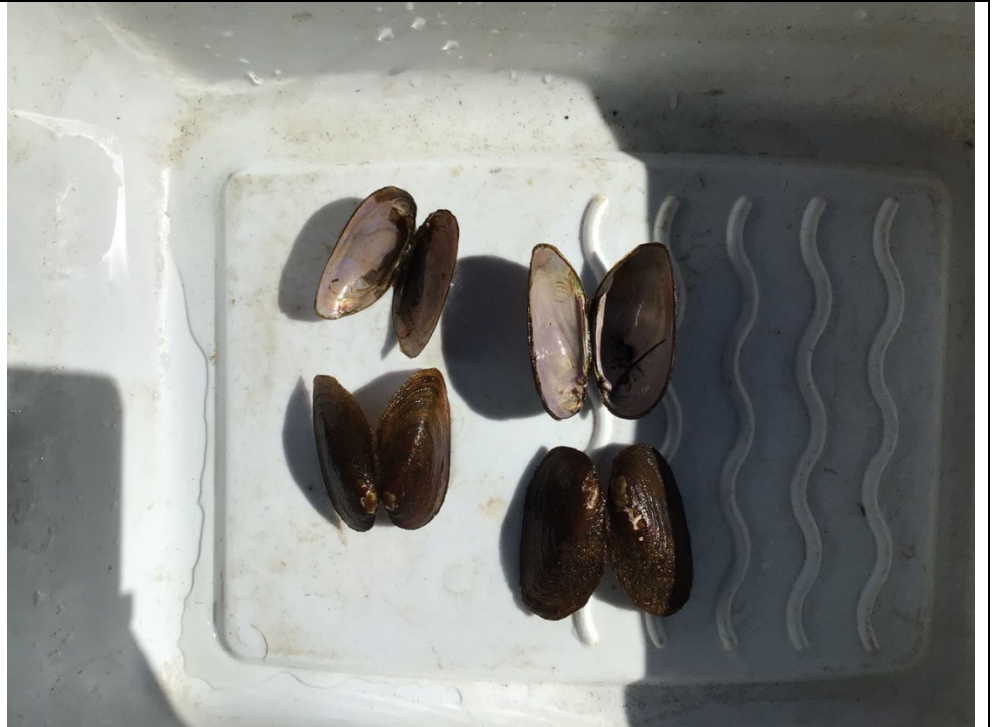
View of mussel shells observed near western corner of the bridge abutment in New Hampshire.
